MORPHOLOGICAL EVIDENCE FOR A PITTING MECHANISM IN DILUTE ALUMINUM ALLOYS. J./Perkins, J. R./Cummings and K. J./Graham / June 1978 (12/18p.

Technical Report No. 9 To the Office of Naval Research Contract No. N00014-78-WR-80105 NR-036-120

MORPHOLOGICAL EVIDENCE FOR A PITTING MECHANISM IN DILUTE ALUMINUM ALLOYS

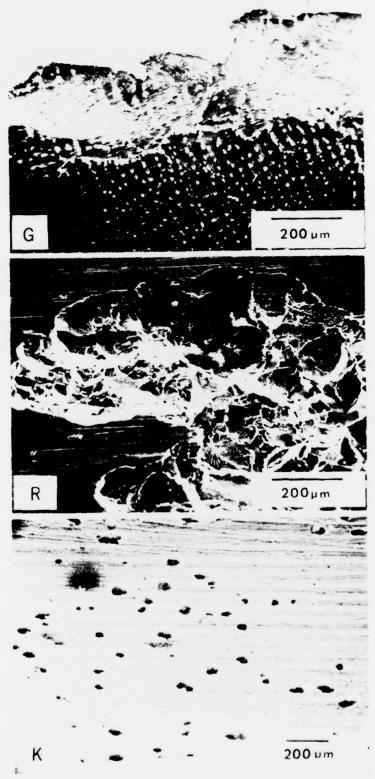
Each of the dilute aluminum alloys has its own unique pattern of dissolution on the macroscopic scale. Alloy G tends to initiate large dissolution cavities along the machined edges and corners of samples (Figure la), Alloy R forms vertically aligned elongated dissolution cavities on the broad faces (Figure 1b), and Alloy K tends to exhibit profuse pitting (lc). These behaviors have been discussed in an earlier report (1) and will not be considered in detail here. The active regions of the anodes are confined to the

Figure 1: Macroscopic dissolution behavior of the aluminum anodic samples in synthetic seawater. Alloy G initiates attack which spreads laterally inward from the specimen edges. Alloy R forms elongated cavities on the broad faces of the specimen. Alloy K forms more (and smaller) dissolution sites per unit surface area.

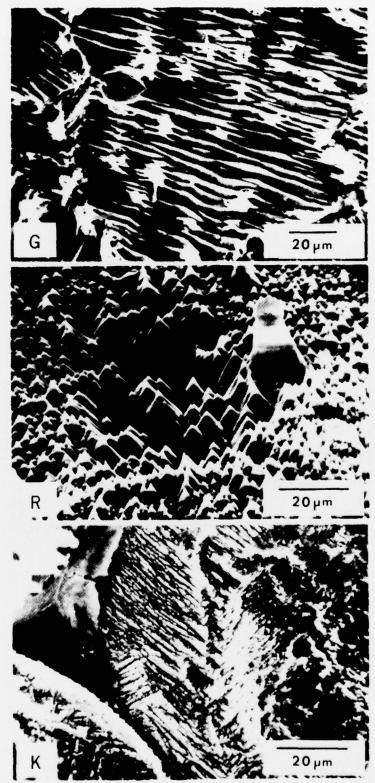
When the dissolution surfaces of these alloys are examined at high magnification in the scanning electron microscope, each alloy is seen to have its own characteristic dissolution morphology. In each case, the attack is distinctly crystallographic in nature, but the specific form differs for each alloy, as illustrated in Figure 2. Alloy G exhibits a unique step pattern, with very little corrosion product accumulation (Figure 2a). Alloy R developes a distinctly different dissolution morphology, consisting of an array of sharp crystallographic peaks (Figure 2b) and in this case also there is little corrosion product on the reacting areas of the surface. Alloy K shows a much less distinct etching pattern than the other alloys, and there is a tendency to accumulate more corrosion product, so that the underlying dissolution morphology is only seen when the corrosion product is knocked off the surface; a tendency to intergranular penetration is also seen for Alloy K. Of course,

Figure 2: Microscopic dissolution morphology found within the dissolution regions of the respective alloys. Alloy G displays a distinct step pattern on all grain surfaces, whereas Alloy R forms surfaces usually made up of sharp peaks; both Alloy G and R accumulate little corrosion product on the dissolution surface. If the corrosion product is removed from Alloy K, a less distinct step structure is seen, with intergranular penetration.

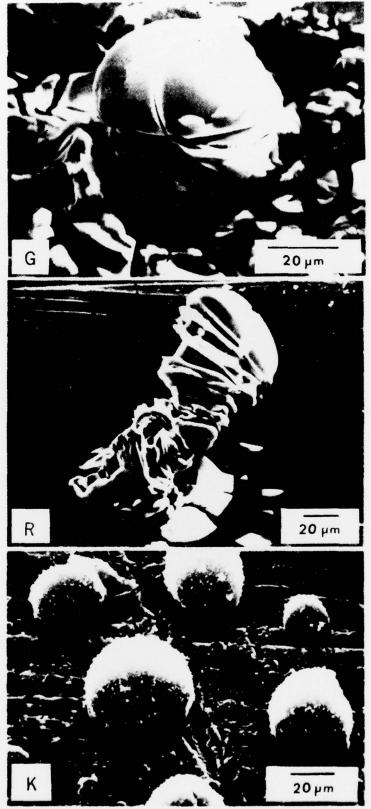
After about 50 hours galvanic exposure, Alloys G and R begin to develop a discontinuous film over their dissolution surfaces. When this occurs, evidence of a true pitting phenomenon begins to be seen. Mushroom-like mounds of corrosion product begin to push their way up at certain sites in the film (Figure 3a). These emerging forms characteristically have a smooth hemispherical cap, and by their form appear to be discontinuously extruded from within the underlying pits (Figure 3b). These eruptions are nearly always located within the mud-cracked film over the dissolution regions; only occasionally are such forms seen to emerge on the unattacked areas of the surface (Figures 4a, 4b). These forms are assumed to consist of a hydrated aluminum oxide corrosion product which has been emitted from the pit mouths by the action of hydrogen gas pressure built up within the occluded cells (pits).

Alloy K shows a somewhat different morphological manifestation of fine-scale pitting phenomenon, consisting of arrays of perfectly hemispherical hollow domes located on the unattacked surface areas of the anode (Figure 3c). These appear much earlier in the exposure history of the anode than the extruded forms on Alloys G and R. These forms again appear to be the result of hydrogen gas evolution within underlying pits. In this case, the pressure inflates the domes by deformation of the general film material. These domes are known to be thin hollow shells because they often are observed broken open (Figure 5), probably due to handling of the specimens. Even when the surface is studied at high magnification, these domes cannot be clearly associated with any physical feature in the general film structure, such as cracks; note in Figure 3c that the general film reflects the underlying grinding marks on the specimen. When these hemispherical pods crack open, an interior filament of very white corrosion product can be seen (Figure 5).

Figure 3: Microscopic observations of true (occluded cell) pitting phenomena observed within the dissolution regions of Alloys G and K when these regions become somewhat filmed over (after several days exposure). Alloys G and K develop mounds with smooth hemispherical caps that emerge from the pit mouths within a cracked film. Alloy K develops inflated pod-like domes in the general film on the unattacked regions of the anode.

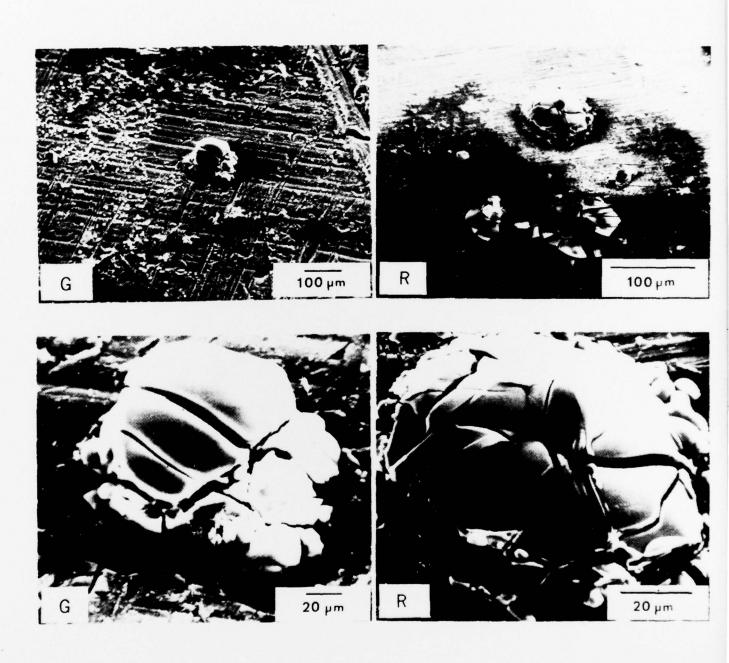
Figure 4: Less frequently observed are pitting and mound features on the unattacked regions of alloys G and R.

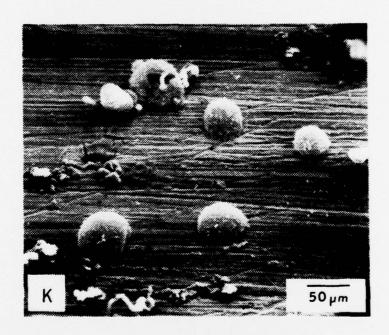
Figure 5: Broken hemispherical pod on Alloy K; note the interior filament of corrosion product emerging from the pit mouth.
